February 4, 2021

Lake Avondale Stormwater Project - Poor Condition Tree Photos

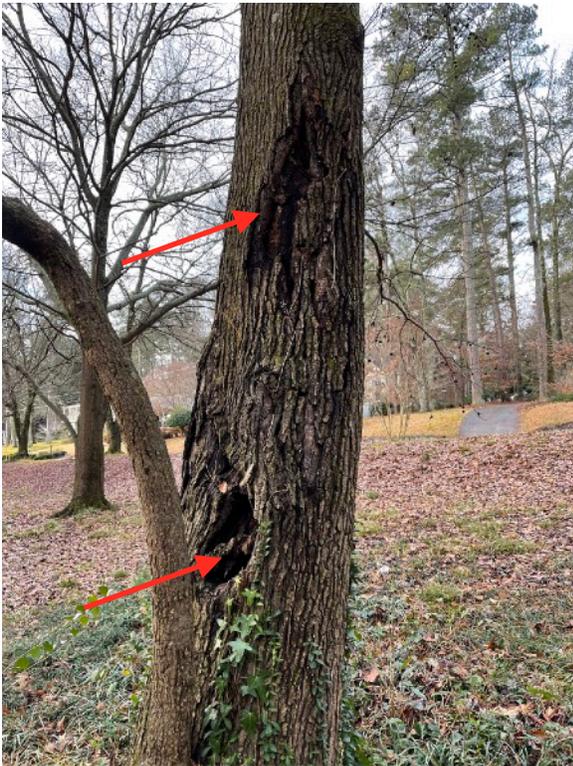
Tree 13 - Dieback in lower trunk

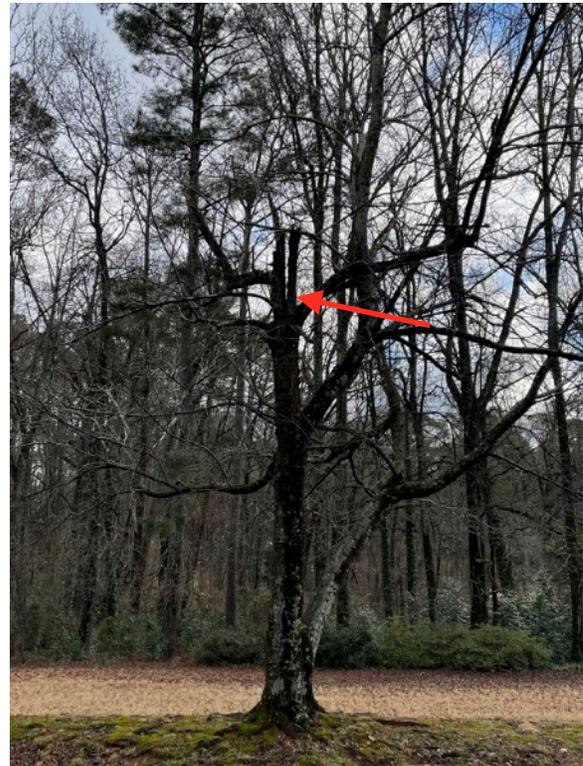
Tree 18 - Low split into two codominant leaders; extensive dieback in canopy

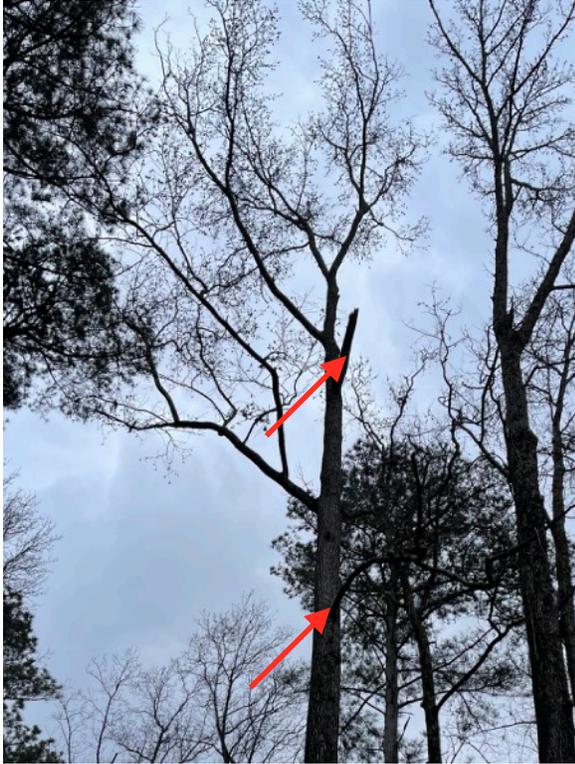
Tree 68 - Dieback in canopy

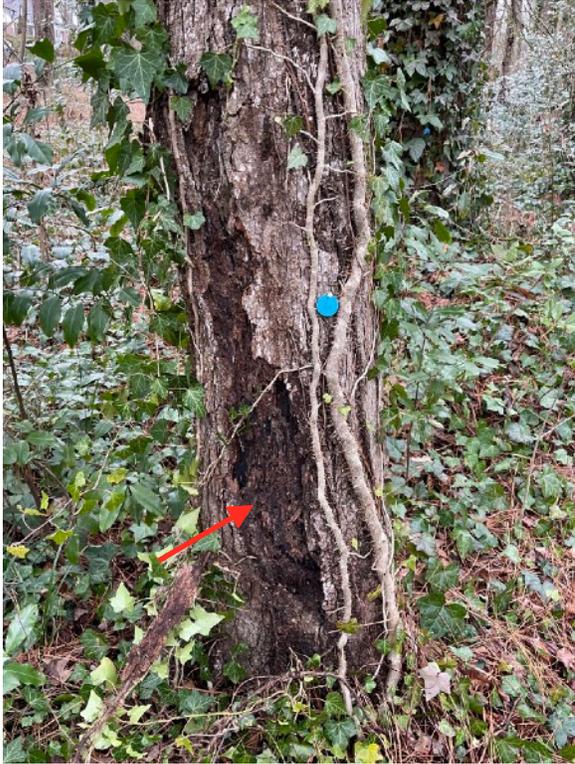
Tree 84 - Several trunks wounds with decay

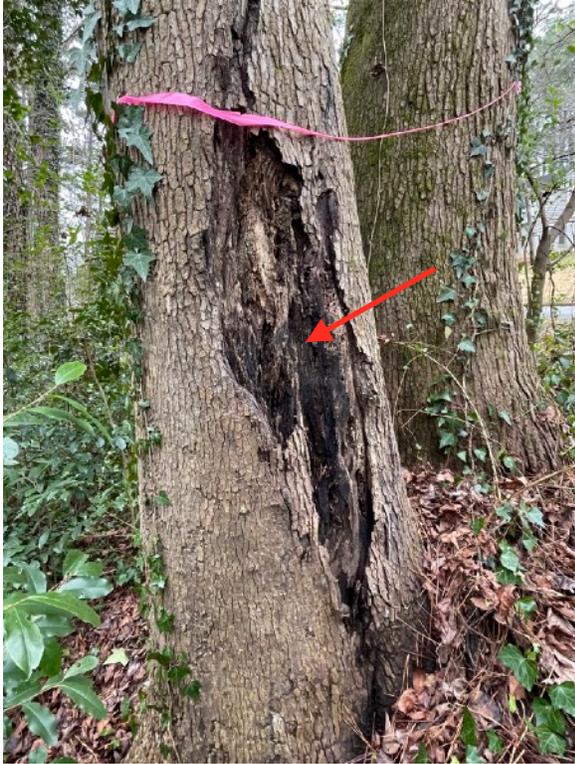
Tree 110 - Trunk wound with decay

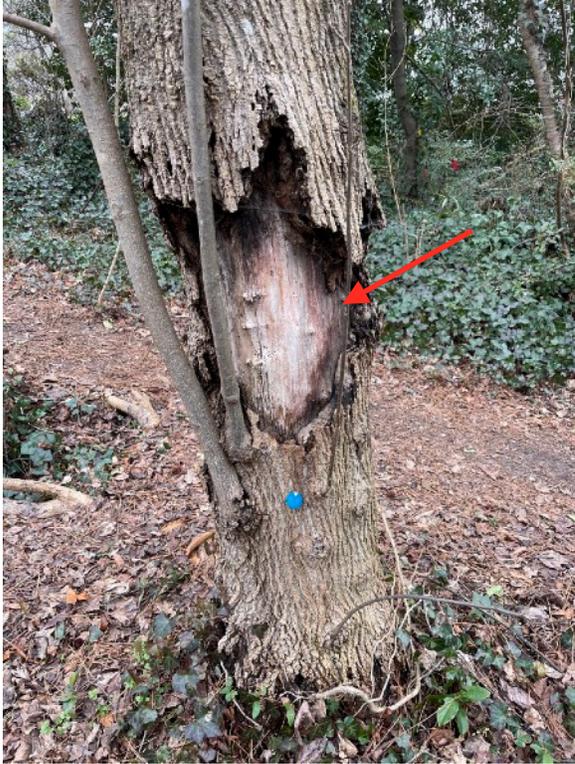
Tree 116 - Trunk wound covering 70% of diameter

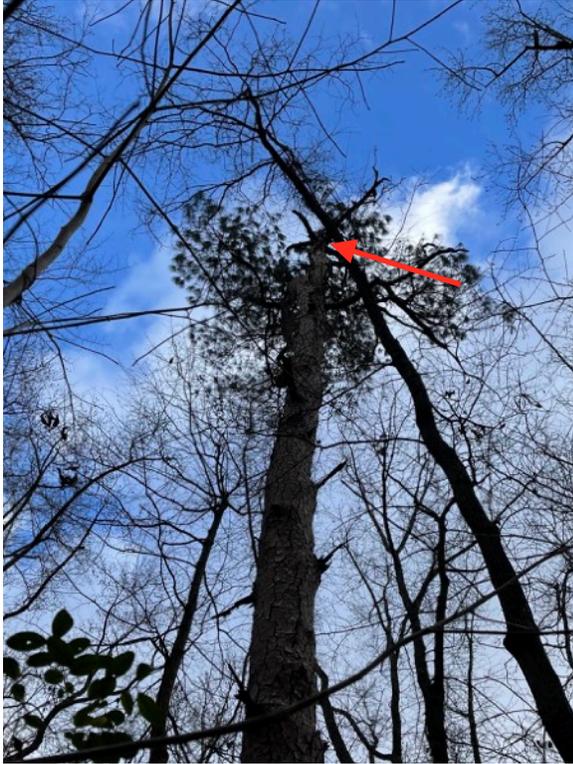
Tree 204 - Damage and dieback in canopy

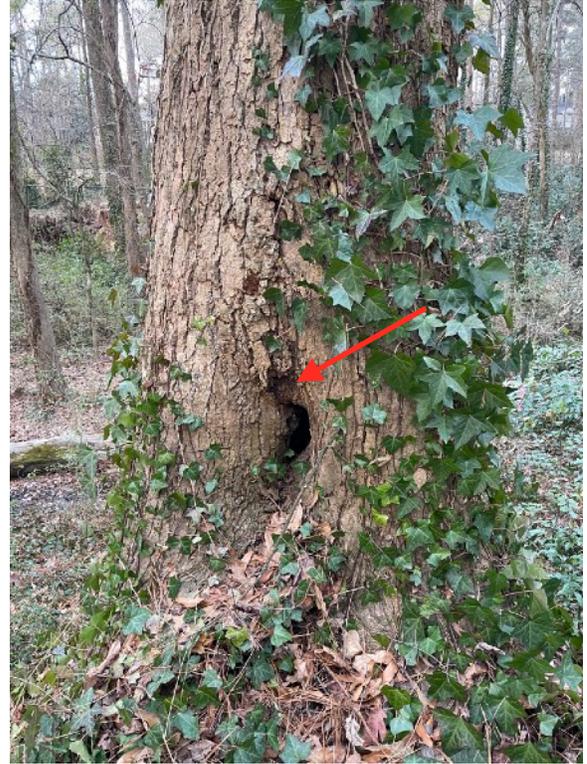
Tree 214 - Cavity in lower trunk

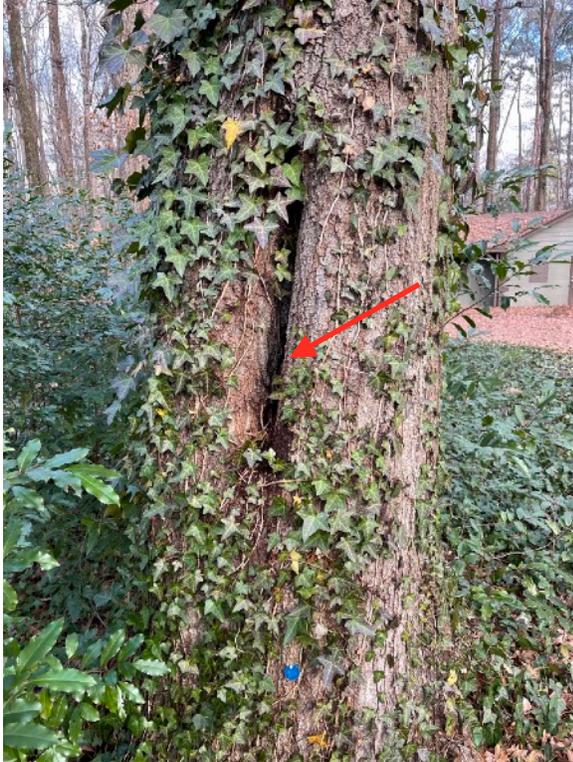
Tree 236 - Cavity and decay in trunk

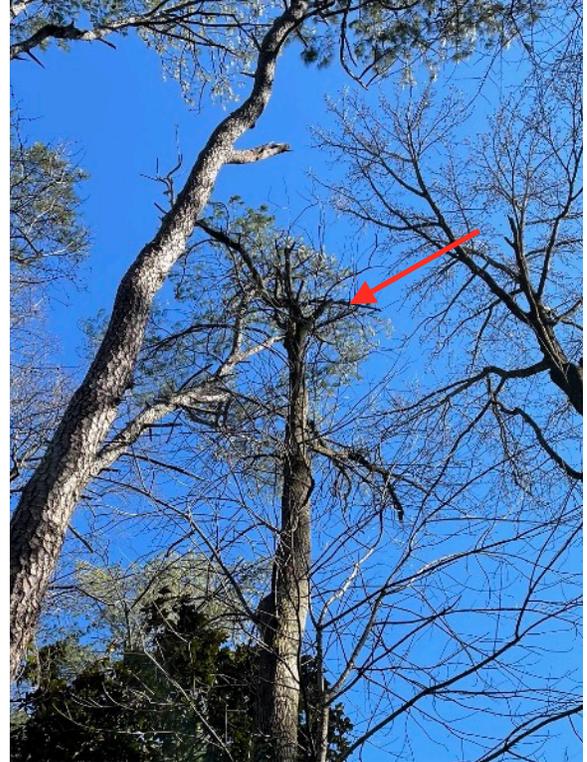
Tree 317 - Dieback in canopy

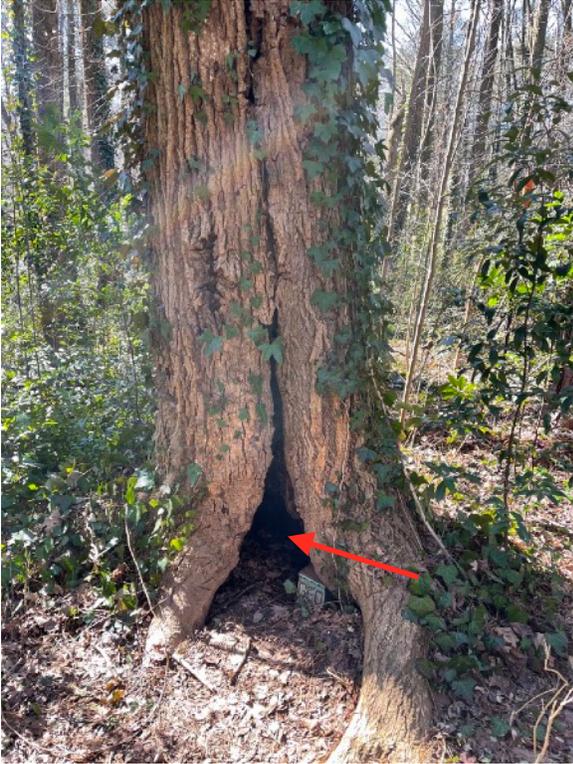
Tree 352 - Cavity throughout trunk

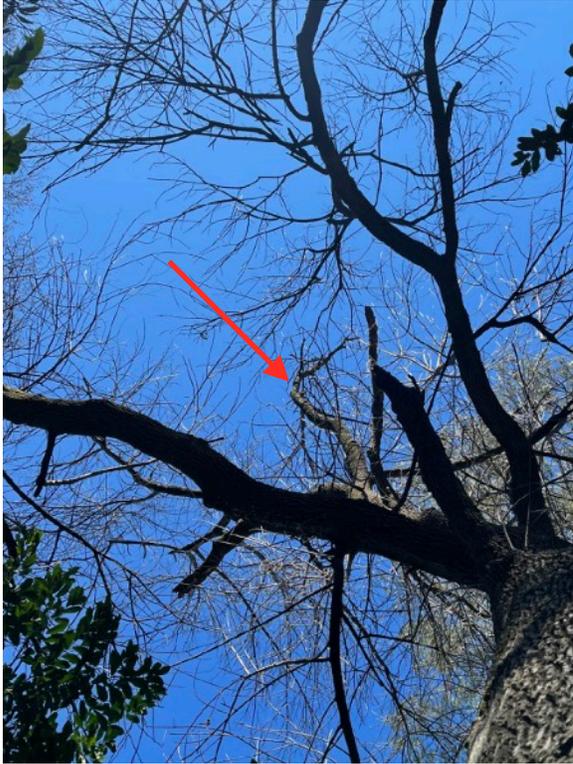
Tree 363 - Dieback in canopy

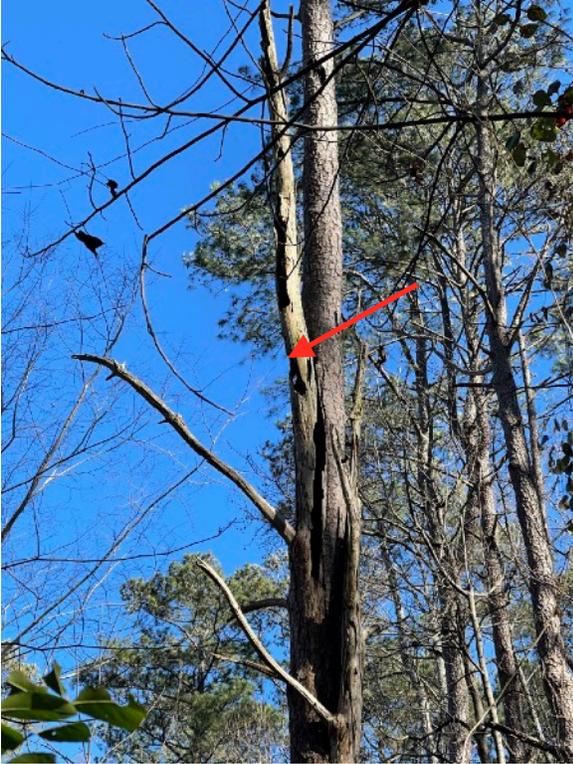
Tree 379 - Cavity in upper trunk

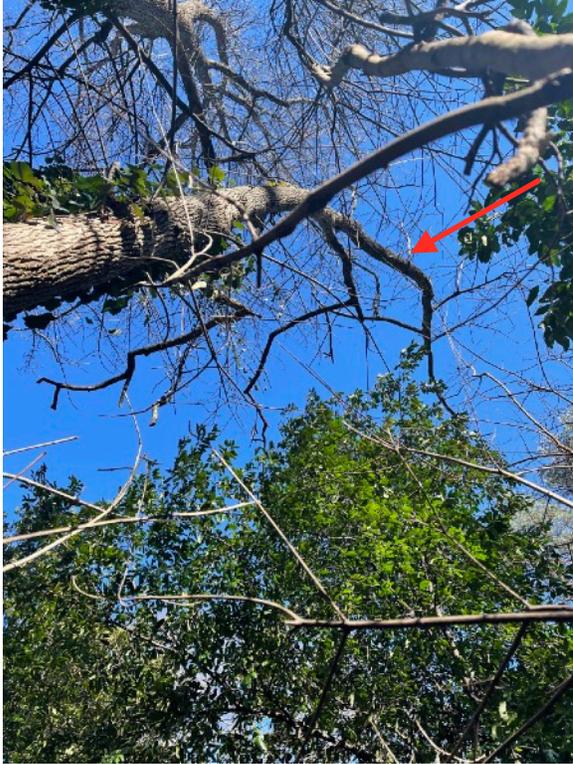
Tree 383 - Dieback in canopy

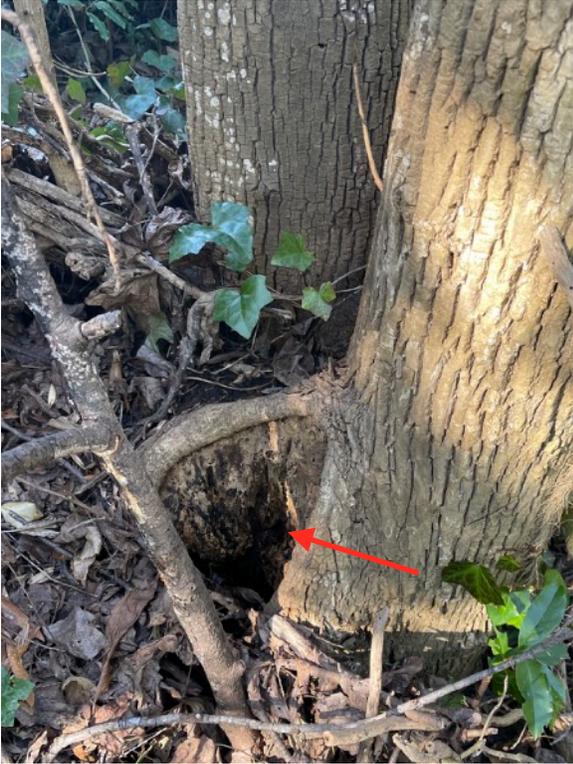
Tree 383 - Multi stem; decay in base
